Asbestos vs Mold? Innovative Solution

Innovative Solution

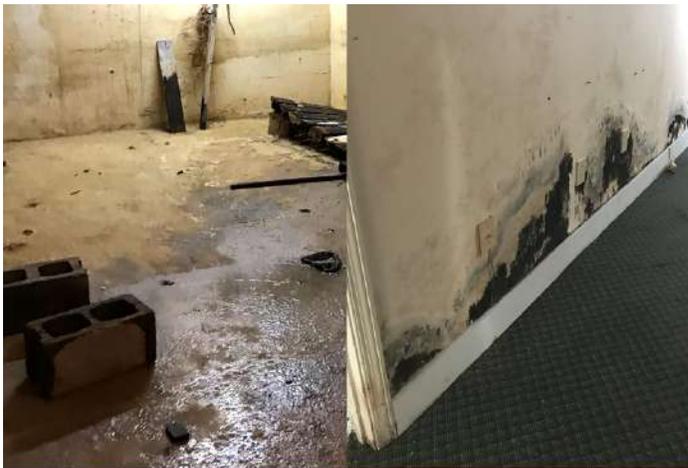
Test Site 1 (TS1) - Water/Mold

who agreed to let us use this facility. Upon inspection, we deemed this a potentially useful location. We called the building Test Site 1 (TS1) - see above photo. The original owner was correct about the presence of mold as the basement was flooded and every room was infested with mold. Based on the age of the building, it seemed likely the wallboards and textured ceiling tiles would contain asbestos. EAQP focused on the ceiling tiles because

they were similar to the type of ceilings with Artex surfacing familiar to our client. EAQP sampled several areas. Test results came back negative.

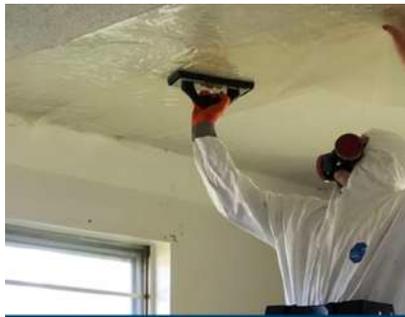
Test Site 2 (TS2) - Asbestos Ceiling

We moved on to what we called Test Site 2 (TS2), a residence that was being gutted and renovated - recommended to us by a general contractor. EAQP tested one bedroom ceiling for asbestos. It came back positive. Because this TS2 ceiling had been painted several times over the years, asbestos structures were sealed to the ceiling and would not come loose when abraded. No airborne particulate, then TS2 had to be abandoned. Not all was lost though as EAQP noted

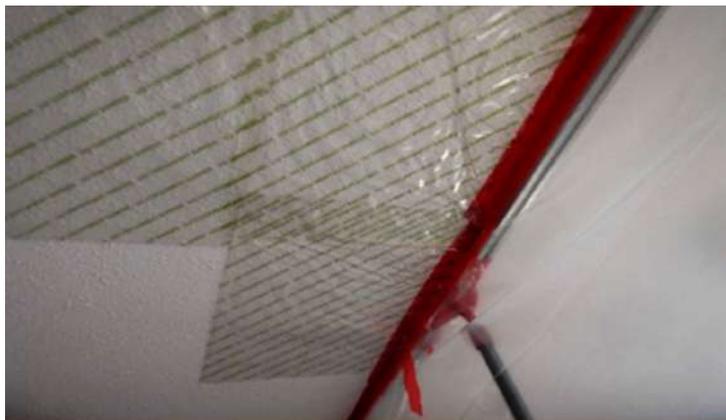
Test Site 3 (TS3) - Inside Containment (L)

would be likely that ACMs were in construction materials that were used. While the downstairs ceilings had been painted, an upstairs bedroom was not compromised by paint. Even better, the bedroom had separate entrances on opposite sides of the room making it perfect to prevent cross contamination.

C. In Containment (L) with a MH/AS treatment covering the ACM textured ceiling, Sample #003 (no air flow) and Sample #005 (with air flow) were taken. Neither sample had ANY detectable amount of Asbestos in the air [<0.035 s/mm²(structures per square millimeter)]; whereas, Outside Containment (R) Sample#004 (with air flow) did contain Asbestos= 162.3 s/mm².
